LASER-INDUCED DAMAGE THRESHOLD (LIDT) MEASUREMENT REPORT

R-ON-1 (CONDITIONING) TEST PROCEDURE

Sample: Sample

Name	Sample
Type	AR Coating (AR @ 1053 nm, AOI = 0 deg)
Dimensions	Ø25.4 x 6.0 mm
Packaging	Paper

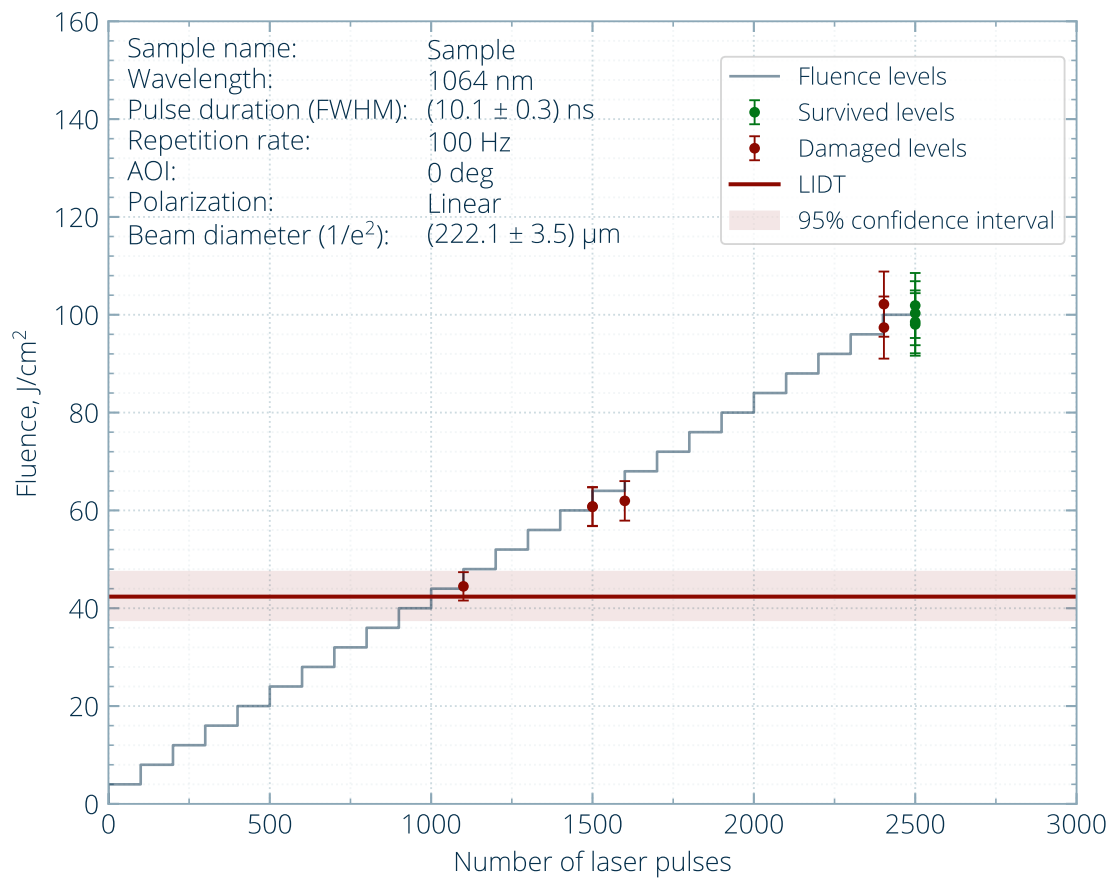
Test mode	Threshold
R(100)-on-1	$42.4^{+5.0}_{-4.7} \text{ J/cm}^2$

Figure 2. R-on-1 test results.

R-on-1 test uses multiple pulses when irradiating single site of the sample. Starting from very low values fluence is constantly increased step by step until damage is reached.

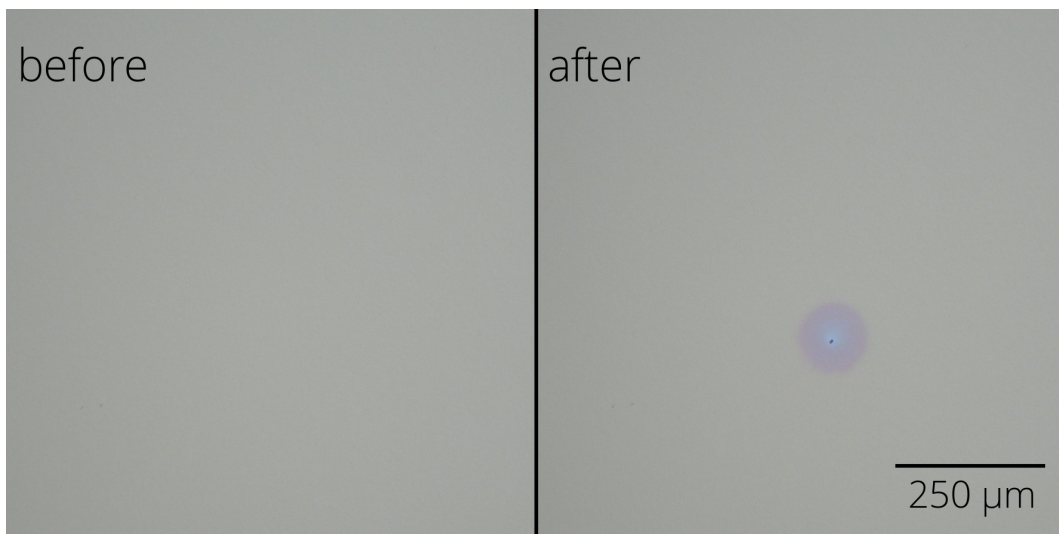
Figure 4. Typical damage morphology: fluence 60.7 J/cm^2 , damage after 100 pulse(s) in fluence level.

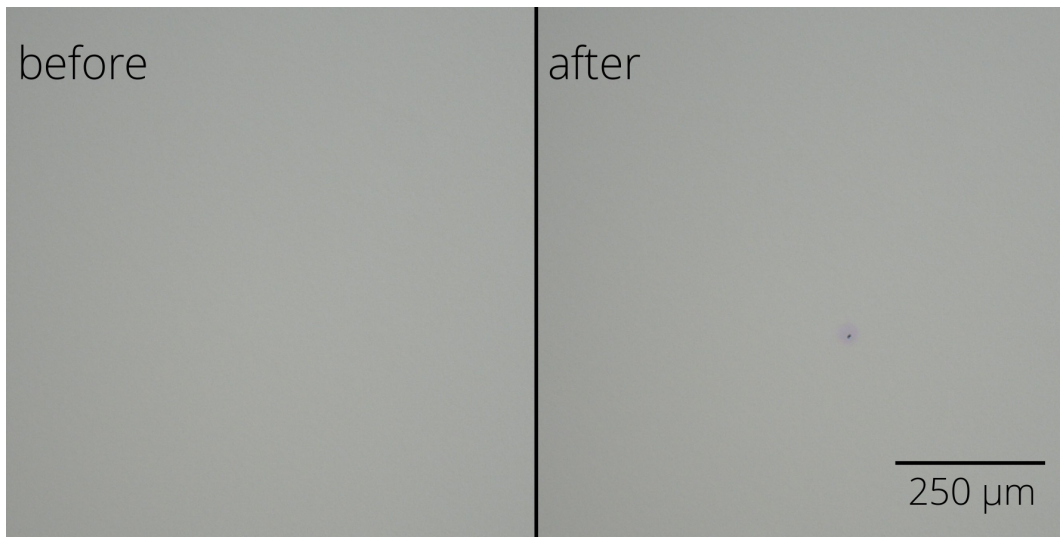
Figure 5. Typical damage morphology: fluence 60.8 J/cm^2 , damage after 100 pulse(s) in fluence level.
