LASER-INDUCED DAMAGE THRESHOLD (LIDT) MEASUREMENT REPORT

R-ON-1 (CONDITIONING) TEST PROCEDURE

SAMPLE: SAMPLE

Name	Sample
Type	AR Coating (AR @ 1053 nm, AOI = 0 deg)
Dimensions	Ø25.4 x 6.0 mm
Packaging	Paper

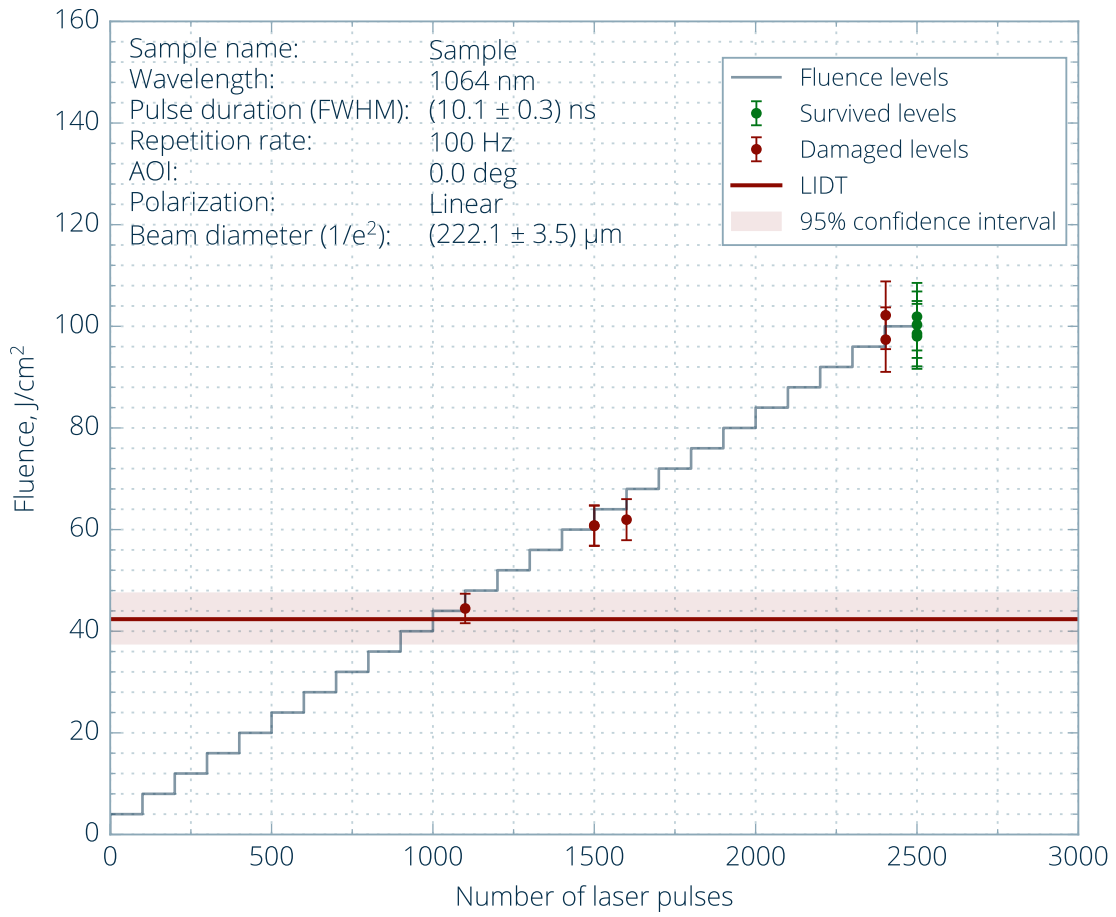
Test mode	Threshold
R(100)-on-1	$42.4^{+5.0}_{-4.7} \text{ J/cm}^2$

Figure 2. R-on-1 test results.

Table 1: Evaluated R-on-1 LIDT for sample Sample.

Test mode	Damaging level	Mean fluence	Number of pulses
R(100)-on-1	11	44.5 $^{+2.9}_{-2.9}$ J/cm ²	100
R(100)-on-1	15	60.7 $^{+4.0}_{-4.0}$ J/cm ²	100
R(100)-on-1	15	60.8 $^{+4.0}_{-4.0}$ J/cm ²	100
R(100)-on-1	16	62.0 $^{+4.0}_{-4.0}$ J/cm ²	100
R(100)-on-1	25	97.4 $^{+6.4}_{-6.4}$ J/cm ²	3
R(100)-on-1	survived	98.0 $^{+6.4}_{-6.4}$ J/cm ²	-
R(100)-on-1	survived	98.6 $^{+6.4}_{-6.4}$ J/cm ²	-
R(100)-on-1	survived	100.3 $^{+6.5}_{-6.5}$ J/cm ²	-
R(100)-on-1	survived	101.9 $^{+6.6}_{-6.6}$ J/cm ²	-
R(100)-on-1	25	102.2 $^{+6.7}_{-6.7}$ J/cm ²	3

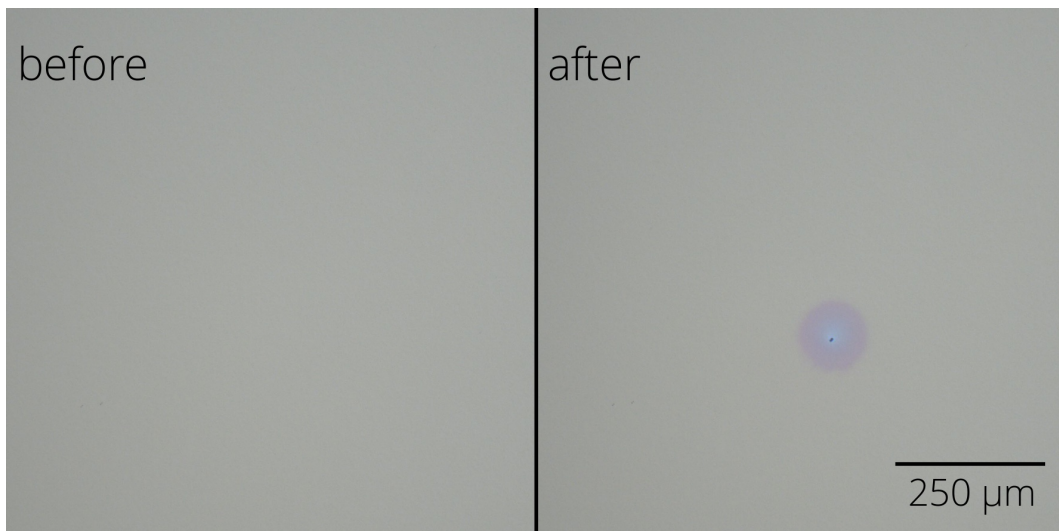
Figure 4. Typical damage morphology: fluence 60.7 J/cm², damage after 100 pulse(s) in fluence level.

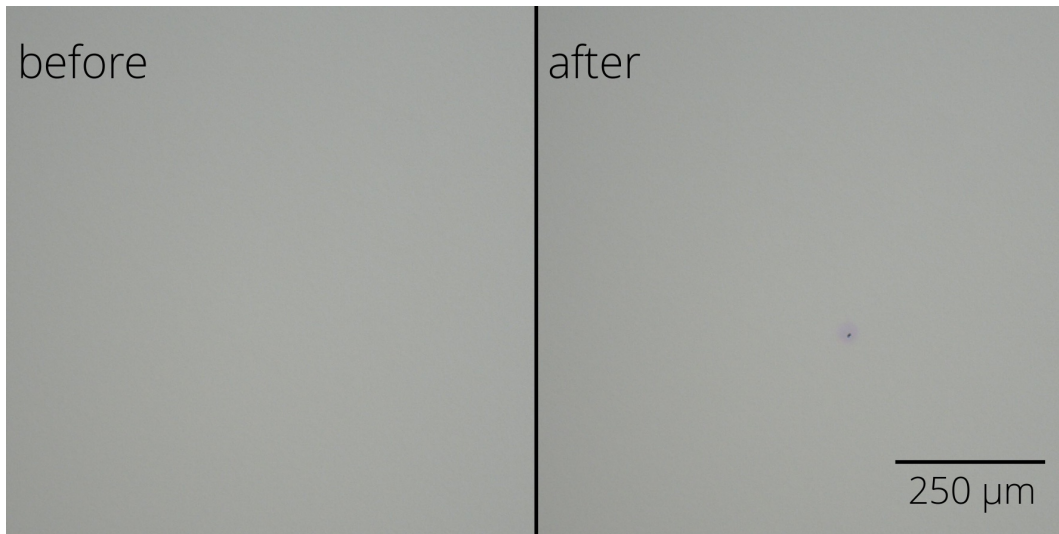
Figure 5. Typical damage morphology: fluence 60.8 J/cm^2 , damage after 100 pulse(s) in fluence level.
