# LASER-INDUCED DAMAGE THRESHOLD (LIDT) MEASUREMENT REPORT

1-ON-1 (ISO 21254-1)  
TEST PROCEDURE

SAMPLE: SAMPLE

Name	Sample
Type	AR Coating
Dimensions	Ø25.4 x 3.0 mm
Packaging	Plastic box

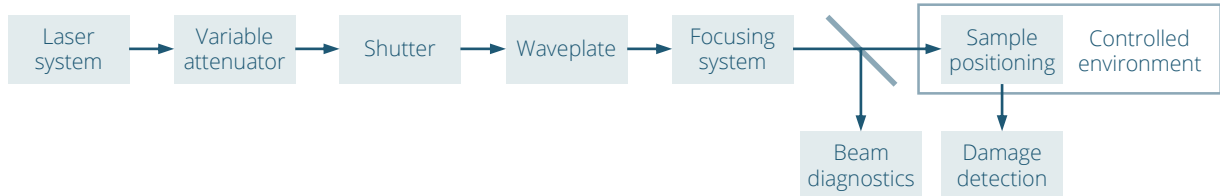
## Test setup

Type	Q-switched, seeded Nd:YAG
Manufacturer	InnoLas Laser II
Model	SpitLight Hybrid
Central wavelength	532.0 nm
Angle of incidence	45.0 deg
Polarization state	Linear
Pulse repetition frequency	100 Hz
Spatial beam profile in target plane	TEM00
Beam diameter in target plane ( $1/e^2$ )	$(216.8 \pm 2.8) \mu\text{m}$
Longitudinal pulse profile	Single longitudinal mode
Pulse duration (FWHM)	$(5.8 \pm 0.3) \text{ ns}$
Pulse to pulse energy stability (SD)	2.6 %

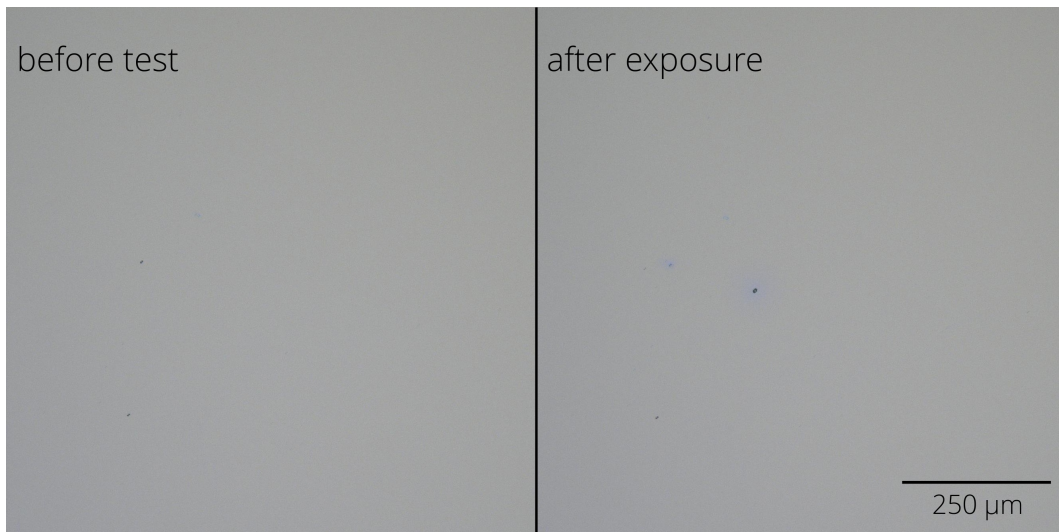
Figure 4. Typical damage morphology: fluence  $17.9 \text{ J/cm}^2$ , damage after 1 pulse(s).

Rear surface damage was observed exposing with more than 16 J/cm<sup>2</sup> fluence laser radiation.

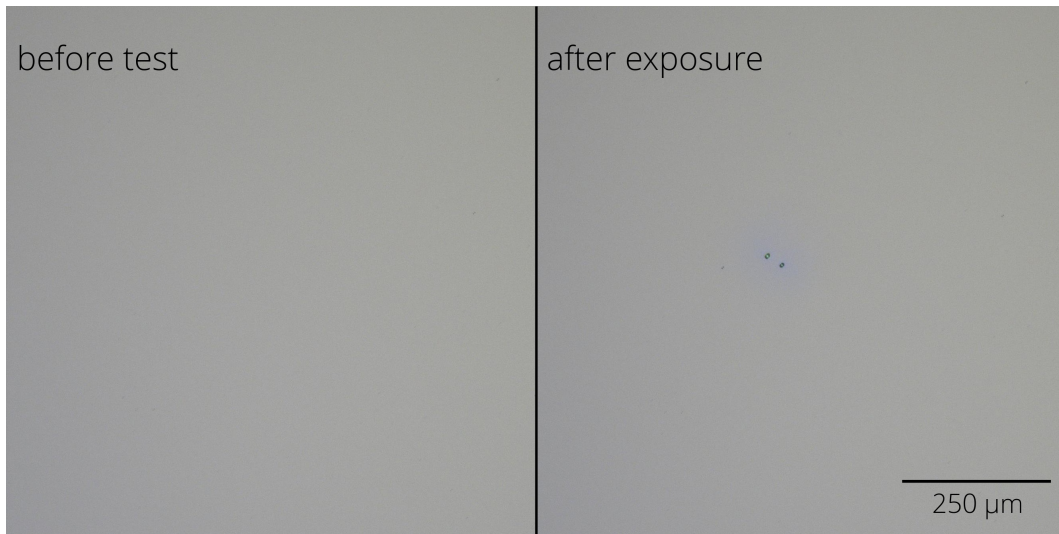
Figure 5. Typical damage morphology: fluence  $21.9 \text{ J/cm}^2$ , damage after 1 pulse(s).

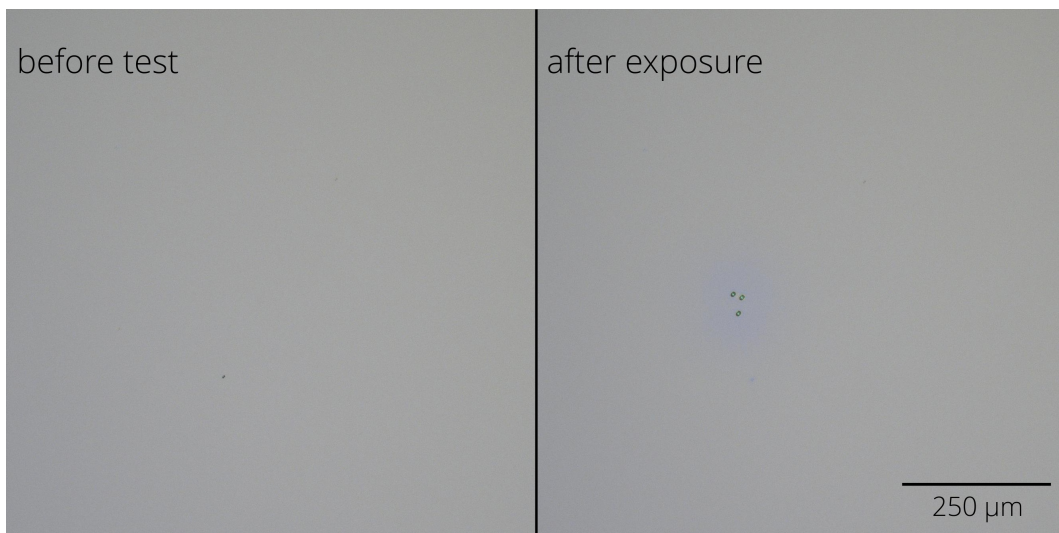
Figure 6. Typical damage morphology: fluence  $26.1 \text{ J/cm}^2$ , damage after 1 pulse(s).
