LASER-INDUCED DAMAGE THRESHOLD (LIDT) MEASUREMENT REPORT

1-ON-1 (ISO 21254-1)
TEST PROCEDURE

SAMPLE: SAMPLE

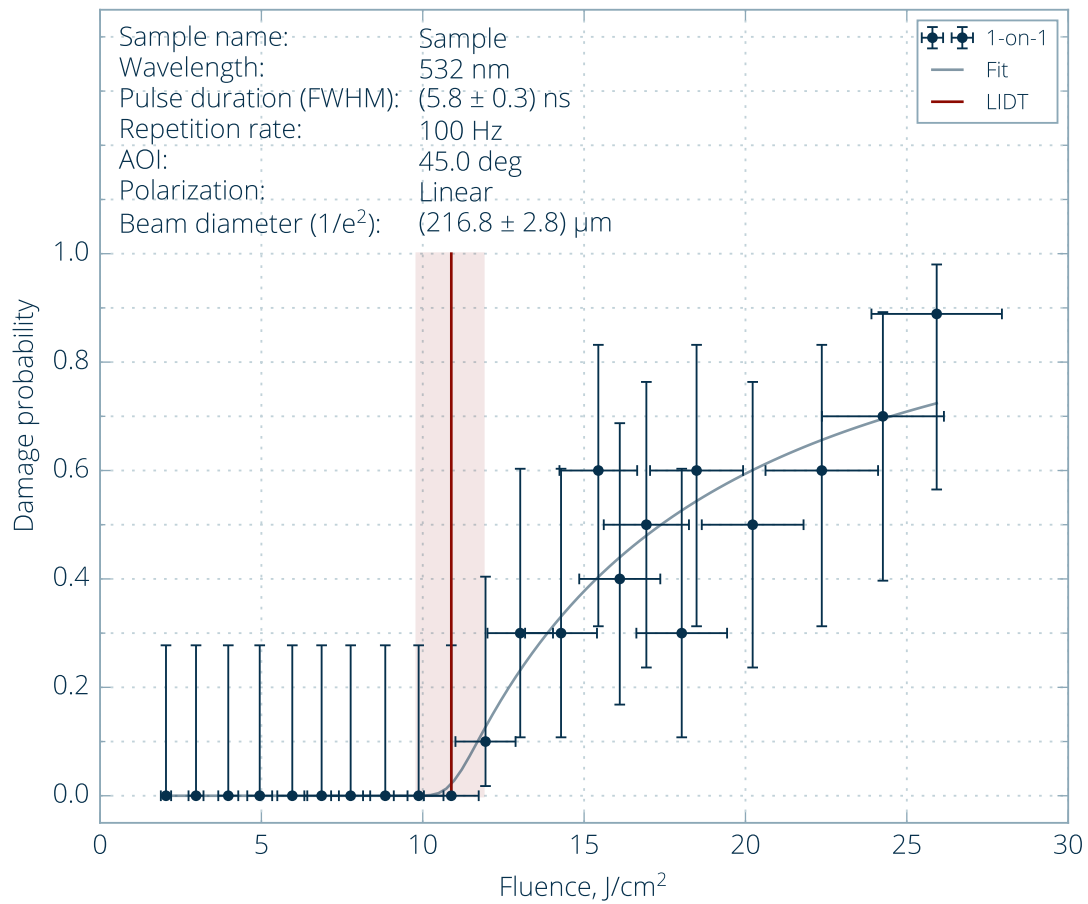
(a) 1-on-1

Figure 2. Damage probability plot.

LID of the sample is investigated by performing a standardized 1-on-1 test procedure.² LIDT value is determined by fitting experimental damage probability data with a model derived for a Poisson damage process assuming degenerate defect ensemble.³

Test mode	Threshold (Offline detection - microscopy)
1-on-1	$10.88^{+0.99}_{-1.12} \text{ J/cm}^2$

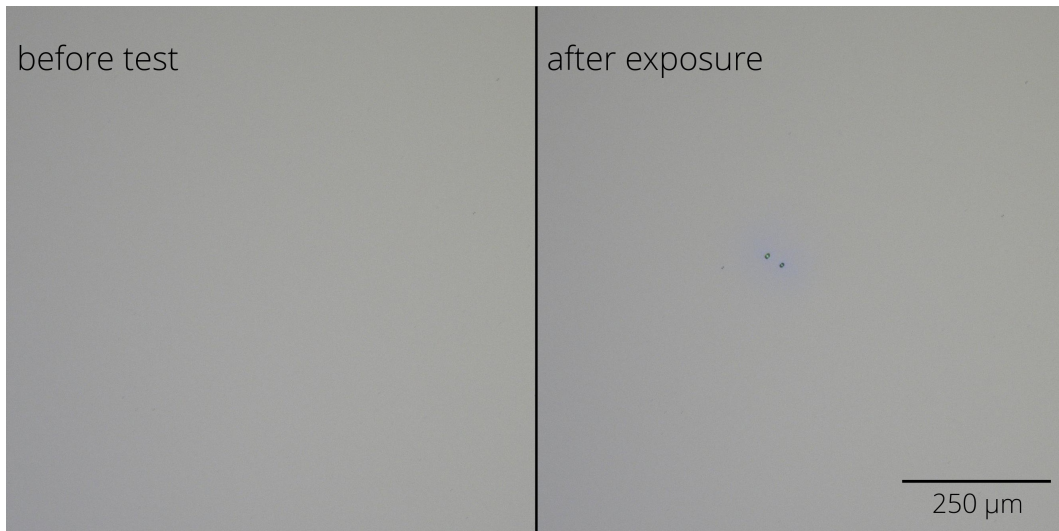
Figure 5. Typical damage morphology: fluence 21.9 J/cm^2 , damage after 1 pulse(s).

Rear surface damage was observed exposing with more than 16 J/cm² fluence laser radiation.

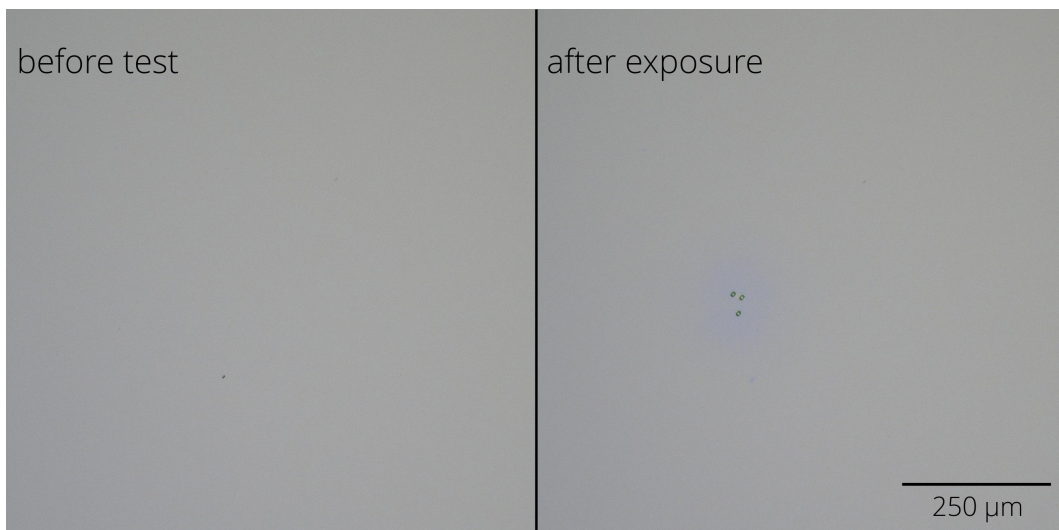
Figure 6. Typical damage morphology: fluence 26.1 J/cm^2 , damage after 1 pulse(s).
