LIDARIS
LIDT Service

LASER-INDUCED DAMAGE THRESHOLD (LIDT) MEASUREMENT REPORT

R-ON-1 (CONDITIONING) TEST PROCEDURE

SAMPLE: SAMPLE

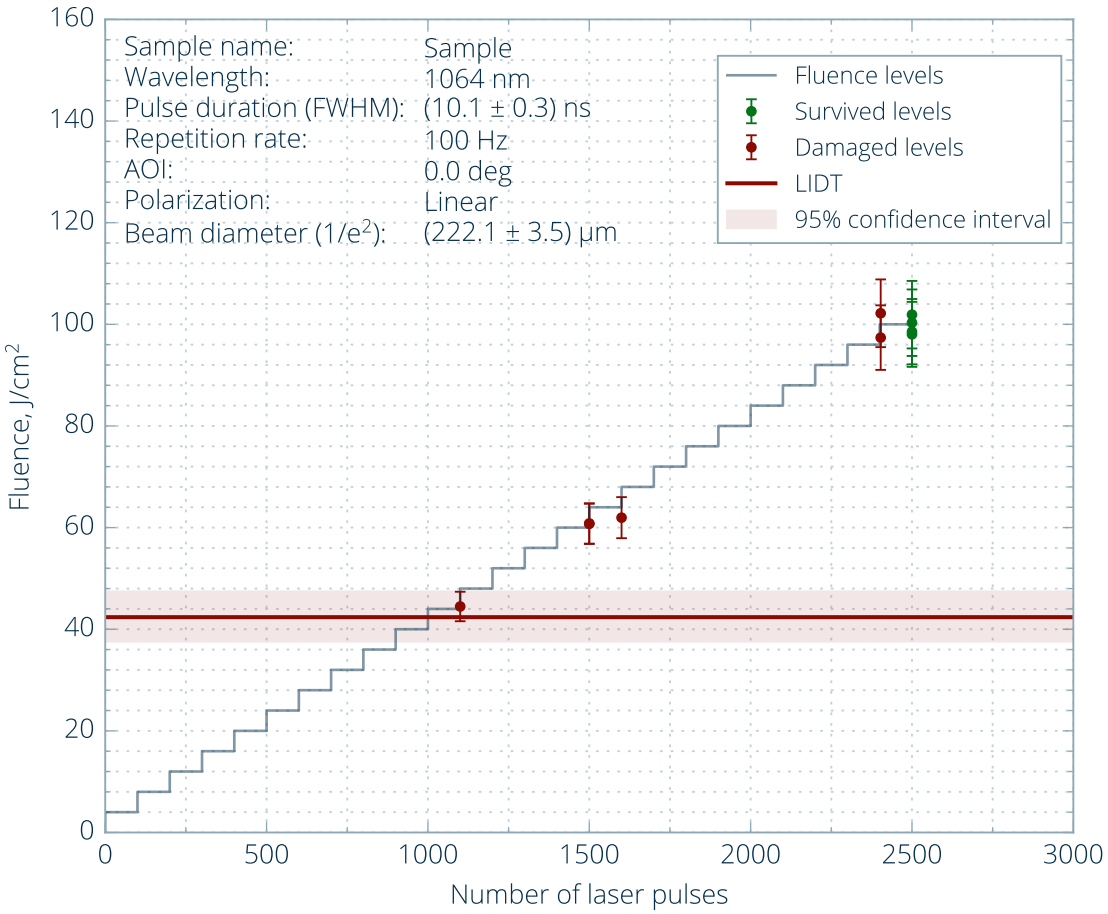
Test mode	Threshold
R(100)-on-1	$42.4\ ^{+5.0}_{-4.7}$ J/cm^2

Figure 2. R-on-1 test results.

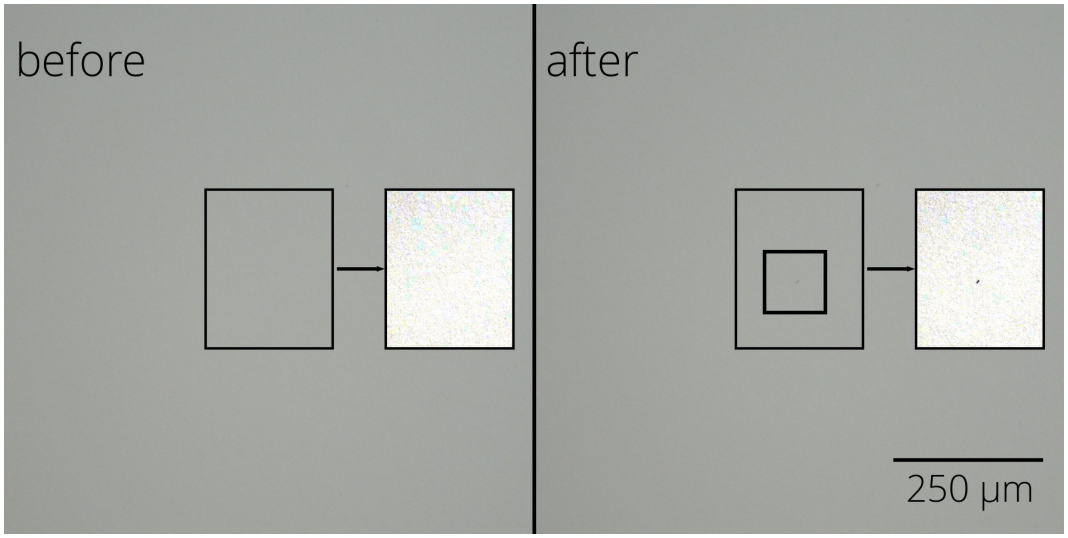
Figure 3. Typical damage morphology: fluence 44.5 J/cm^2, damage after 100 pulse(s) in fluence level. High contrast image.

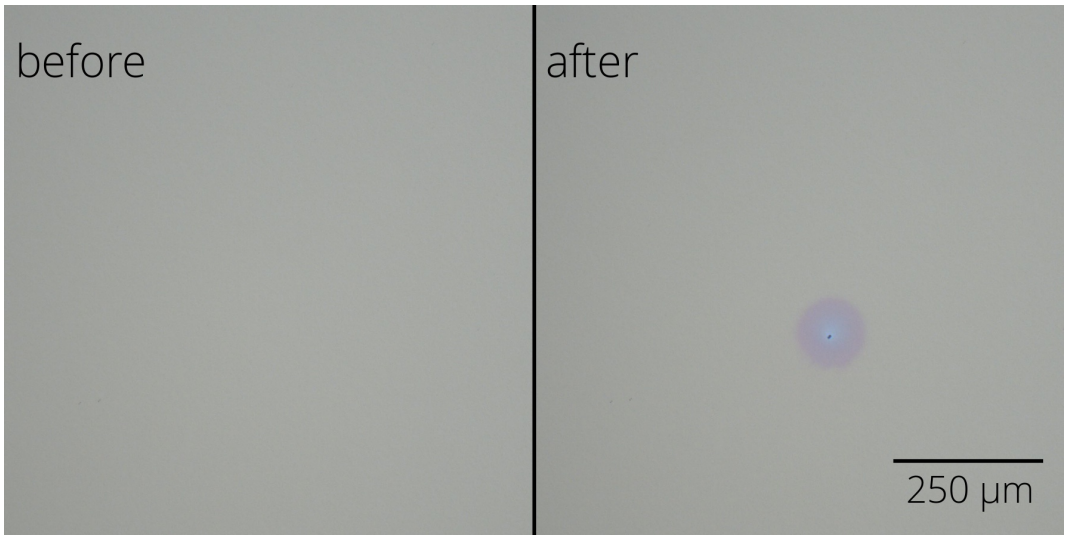
Figure 4. Typical damage morphology: fluence 60.7 J/cm^2, damage after 100 pulse(s) in fluence level.
