LIDARIS
LIDT Service

LASER-INDUCED DAMAGE THRESHOLD (LIDT) MEASUREMENT REPORT

SAMPLE: SAMPLE

Specimen	
Name	Sample
Type	AR Coating
Dimensions	Ø25.4 x 6.4 mm
Packaging	Plastic box

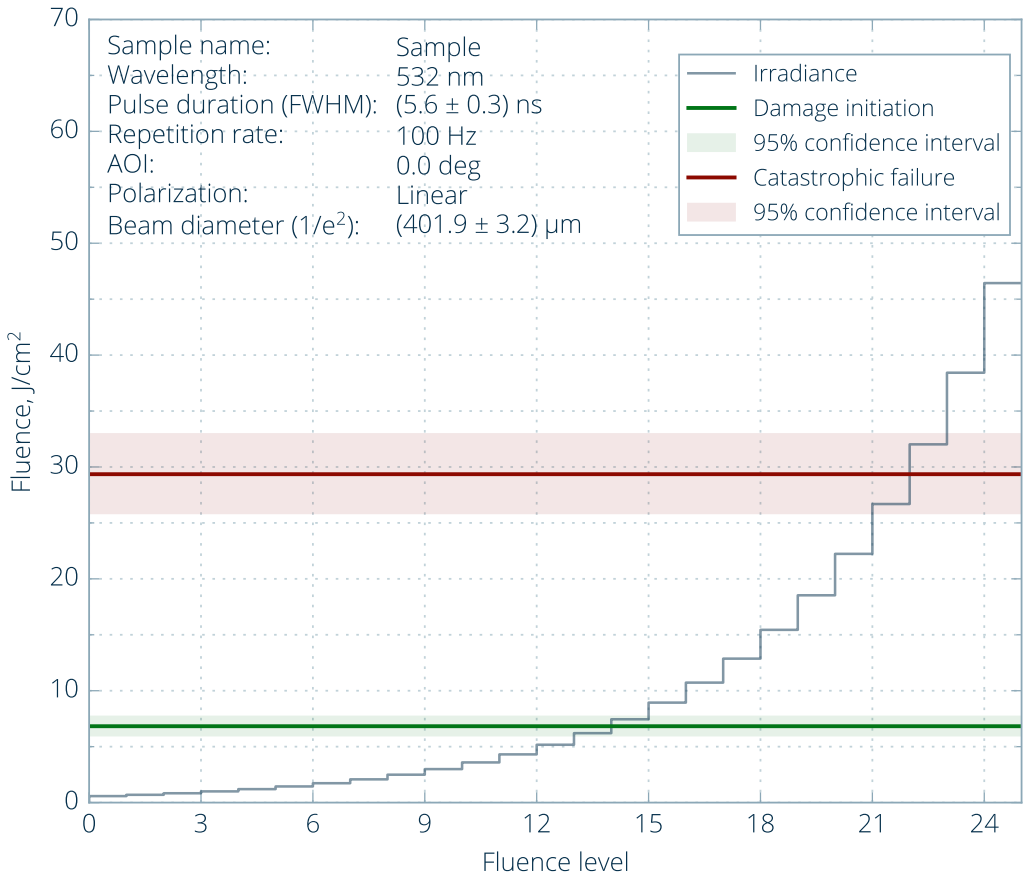
Figure 2. Raster scan test results.

Analysed Threshold type	Threshold
Damage initiation	$6.83\ ^{+0.83}_{-0.80}$ J/cm^2
Catastrophic failure	$29.35\ ^{+3.56}_{-3.46}$ J/cm^2

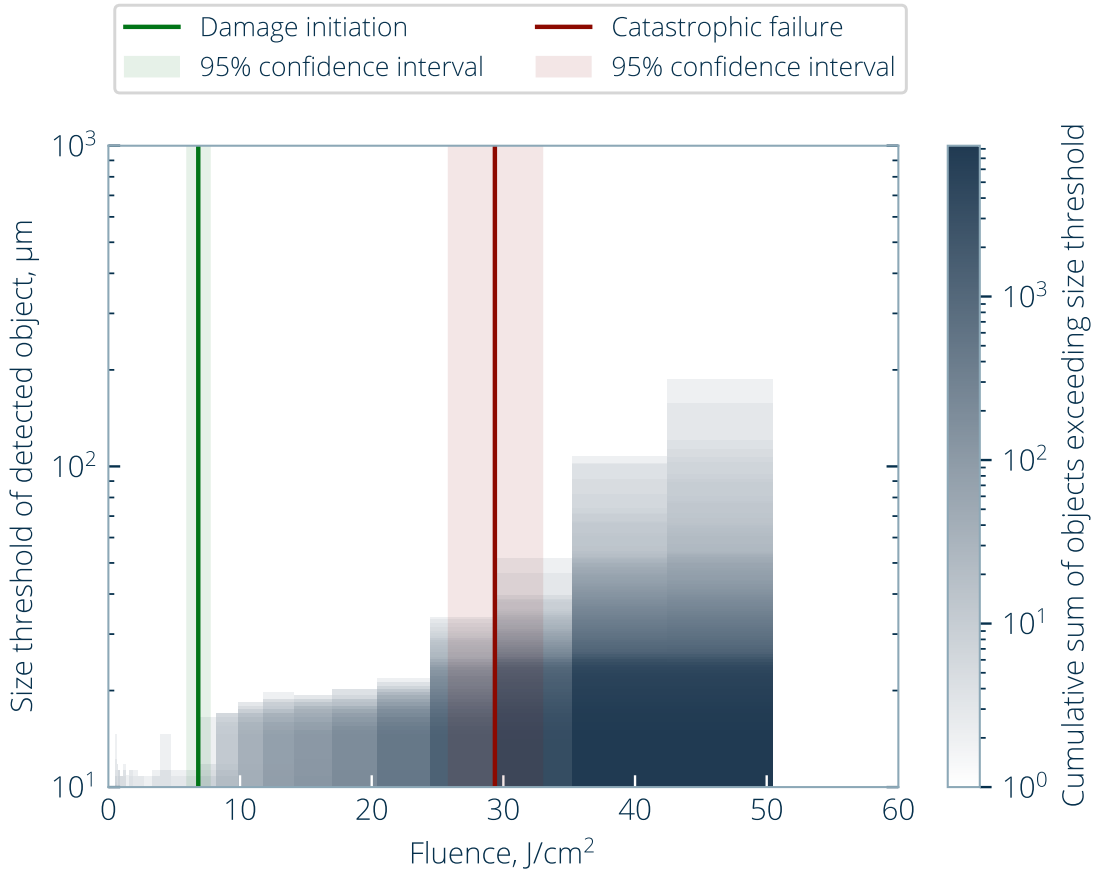
Figure 3. New objects distribution.

Microscopic images are taken before the test and after each new scan. All images are analyzed for new objects (defects). A figure of new object distribution displays the cumulative distribution of objects exceeding defined object size for each new scan level. New objects are defined as objects, that can be distinguished from surrounding area while applying various image analysis methods.

Due to variability in sample initial preparation condition (cleaning) and complexity in image analysis tools, there exists some "noise level" that can be seen at low fluence levels. At higher fluence levels, where counts of new objects increase exponentially, the majority of new objects can be attributed to laser-induced damages of ablation products. The cumulative sum of all found objects is calculated for each fluence level. The apparent area of the object is approximated with the circle and turned into the effective diameter. The size of the object is calculated as the diameter of that circle, independently of the shape of the object.

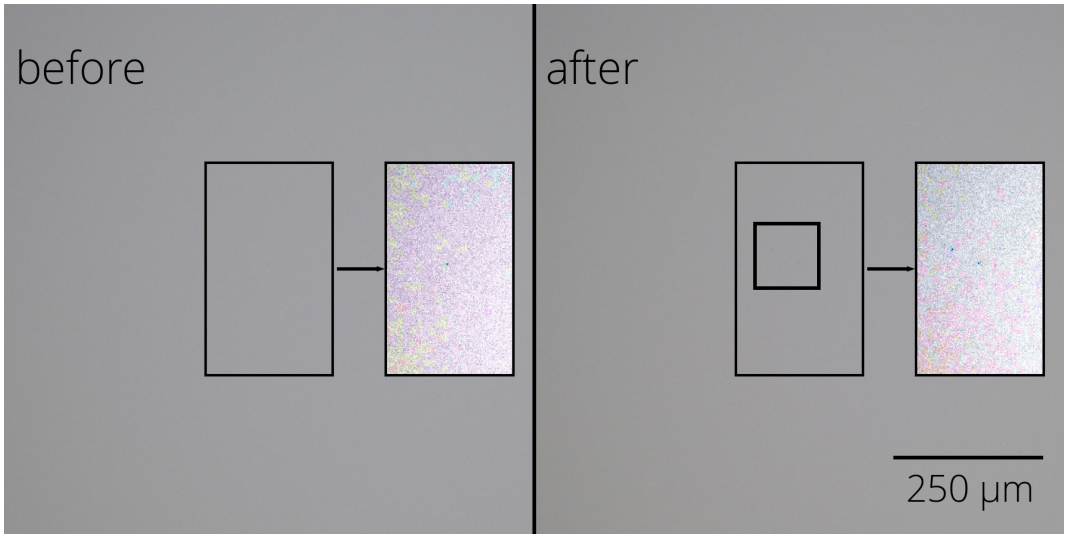
Figure 5. Typical damage morphology: fluence 7.448 J/cm^2. High contrast image.

Damage initiation – minor damages (small pin-points, smooth color changes, etc.) occurred. In general, they might not affect spatial properties of laser beam that irradiates the optical element but these damages can grow into further upon laser exposure.

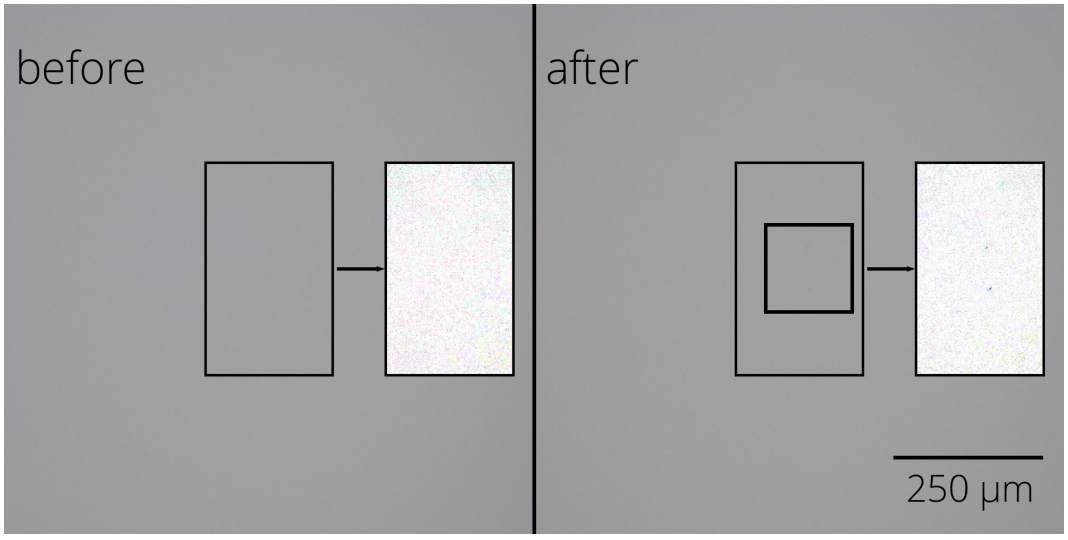
Figure 6. Typical damage morphology: fluence 10.724 J/cm^2. High contrast image.

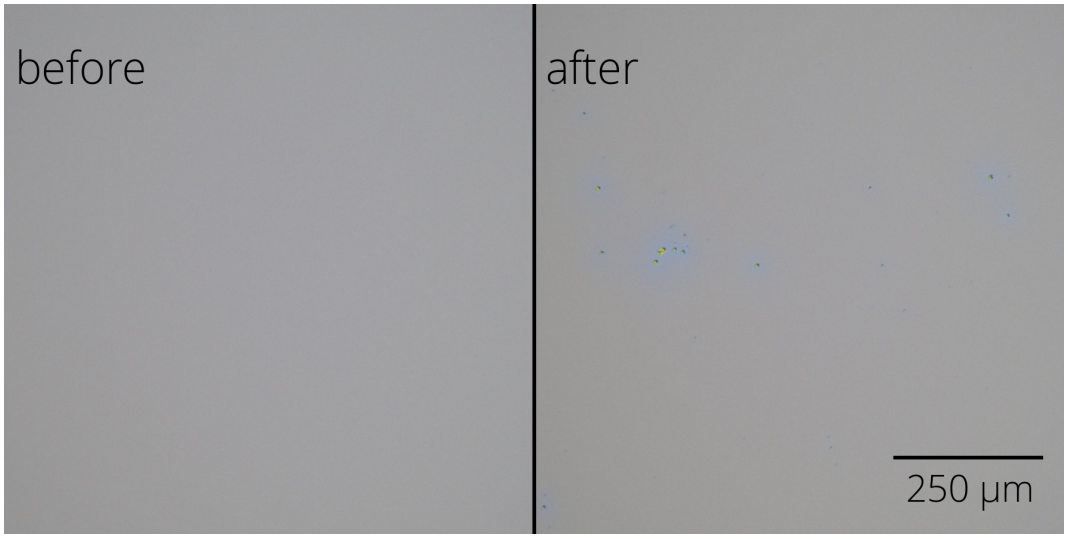
Figure 7. Typical damage morphology: fluence 32.022 J/cm^2.

Catastrophic failure – clearly observed damage that is bigger than 100 µm or the damage that experienced exponential or asymmetric growth after scanning the surface with higher fluences.

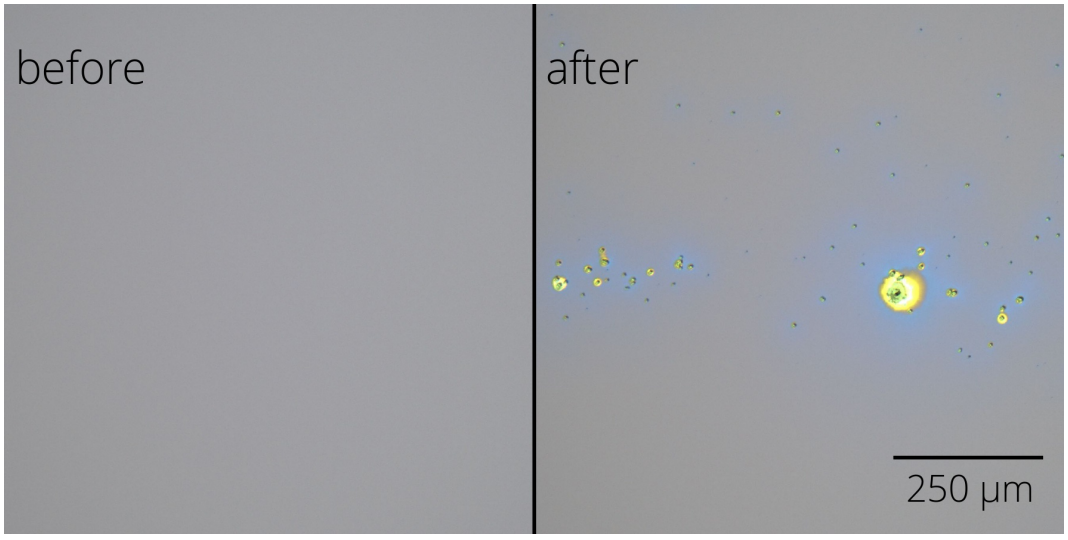
Figure 8. Typical damage morphology: fluence 46.436 J/cm^2.
